WL-TR-96-4015

CERAMIC BEARING DEVELOPMENT

VOL 1, FATIGUE AND WEAR BEHAVIOR OF NBD-200
SILICON NITRIDE BALLS

MARCH 1995

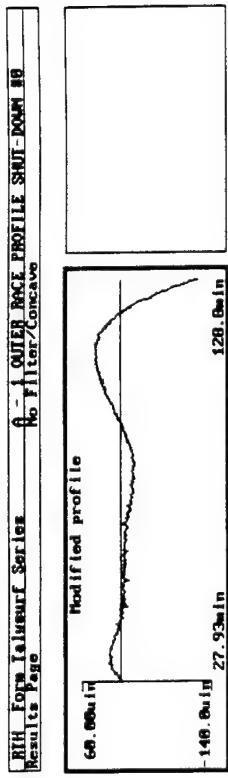
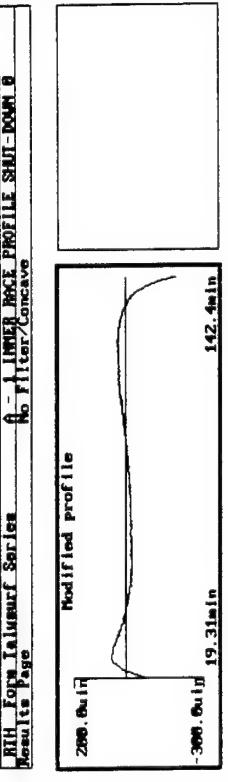
Ra Init = 1.1459 μ in
Rt Init = 11.1919 μ in

Ra Init = 0.4671 μ in
Rt Init = 6.7906 μ in

Test Conditions
276 Hrs. 54.091 X 10^6 Revs
2.76 GPa (400 ksi)
 $\lambda = 1.0$ T = 60°C (140°F)

Figure 31 Wear Test Results For AISI 52100 Steel Race Bearing "A-1".

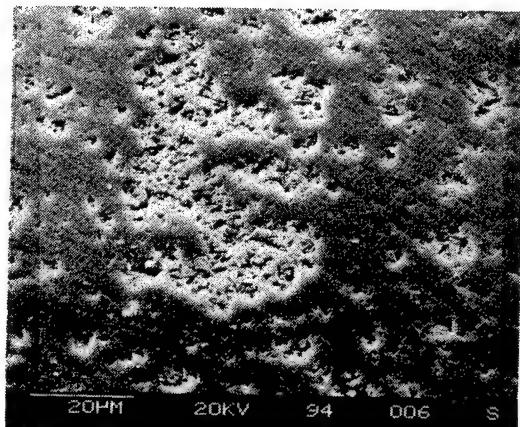
Figure 32 shows the general condition of the inner and outer races after the test. In comparison to Figure 28, the races have a much smoother appearance, with little of the original grinding texture remaining. The balls showed a definite circumferential line of damage in the form of "peeling" or shallow grain pullout, Figure 33. The depth of the peeling damage was measured at less than $0.25 \mu\text{m}$. This material removal appears to have been caused by the stress concentrations associated with over-running the debris bruises and pits in the failed races. Figure 34 shows the commonly-observed "cloud" of silicon nitride particles impressed into the steel surface at the outlet side of race discontinuities. A potential wear mechanism in hybrid bearings could be one which starts with a pit or bruise in the races, from micro-spalling due to fatigue or from an inadvertent debris particle. Wear could then proceed by progressive removal of grains from the silicon nitride surface and corresponding damage to the steel races from the roughened balls and the debris generated in the process.

Figure 33 Damage To NBD-200 Ball From Spalling Of 52100 A-1 Race: (a) Wear Track, (b) Detail Of Shallow Surface Damage, (c) Trace Across Damaged Wear Track.

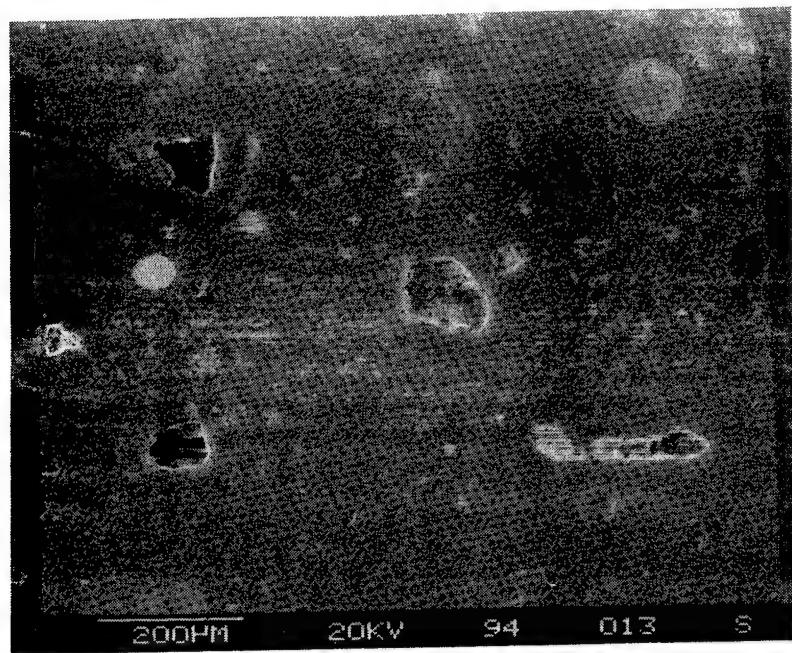
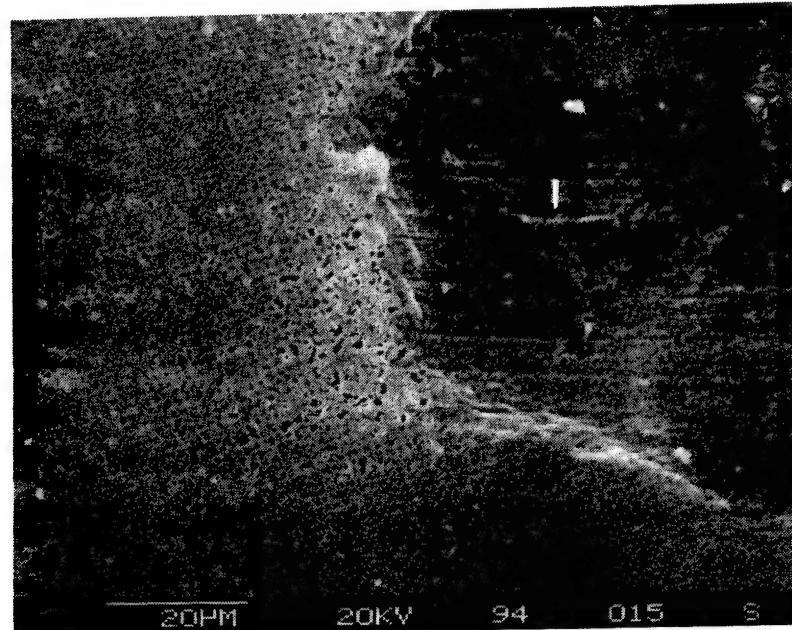
Figure 34 Damage To Bearing 52100 A-1 Outer Race From Debris: (a) General Bruising And Pitting, (b) Detached Si_3N_4 Particles Impressed Into Race At Bruise.

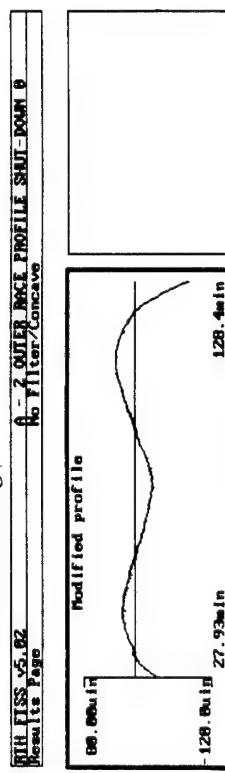
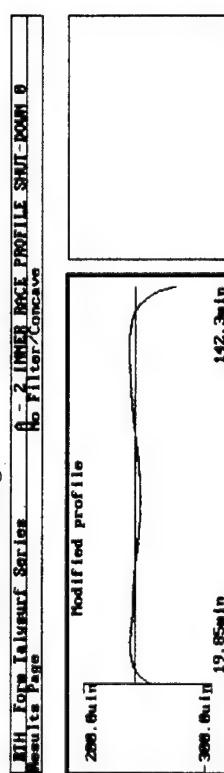
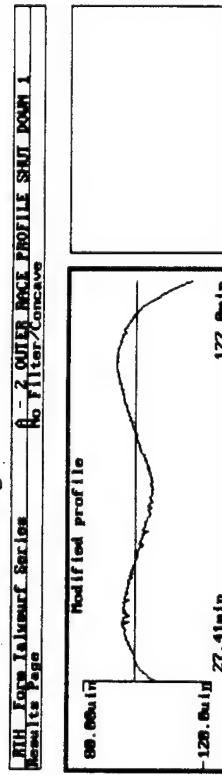
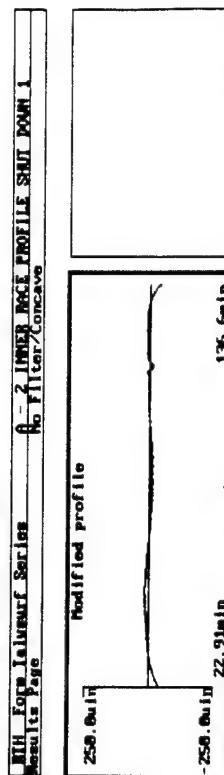
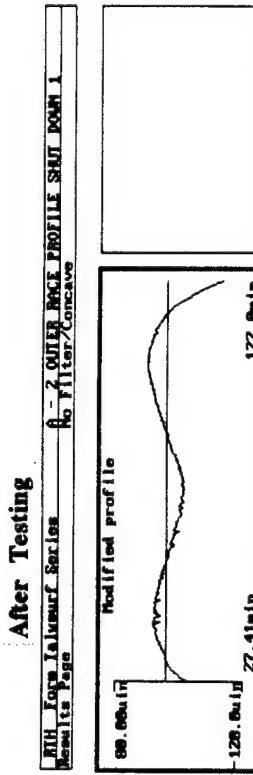
The wear measurements on bearing 52100-A-1 were obscured by the macro-spalling which occurred, so the next run was scheduled for one-half the running time of the first test, to avoid fatigue failure of the races. Bearing 52100-A-2 was run for 147 hours prior to inspection. Figure 35 summarizes the dimensional traces and weight change measurements which were made on the components of this bearing. The profile traces indicate very little change, with the exception of some roughening due to pitting and denting.

The change in the measured surface finish is not felt to be significant. The change in weight is also not significant, actually indicating an apparent weight gain by the races.

Outer Race
Ra Init = 0.6771 μ in
Rt Init = 6.6289 μ in

Outer Race
Ra Final = 0.6602 μ in
Rt Final = 5.6444 μ in

Inner Race
Ra Init = 0.5361 μ in
Rt Init = 4.4414 μ in

Inner Race
Ra Final = 0.8270 μ in
Rt Final = 8.2624 μ in

Wt. Change +0.0002 gm
Test Conditions
147 Hrs. 26.476 X 10⁶ Revs
2.76 GPa (400 ksi)
 $\lambda = 1.0$ T = 60°C (140°F)

Figure 35 Wear Test Results For 52100 Steel Bearing "A-2".

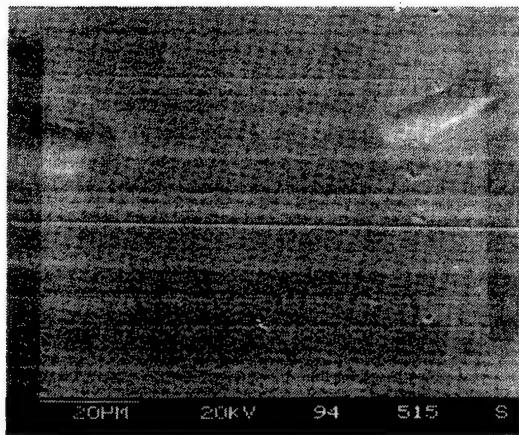
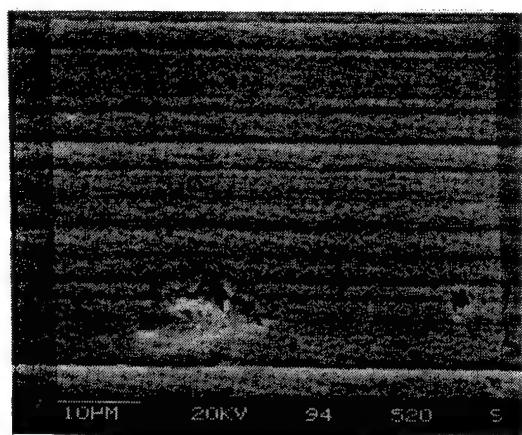
Figure 36 Post-test Condition of AISI 52100 Races, Bearing A-2 Plastic Blunting of Grind Texture, Pitting and Debris Denting (a,b) Outer Race, (c,d) Inner Race.

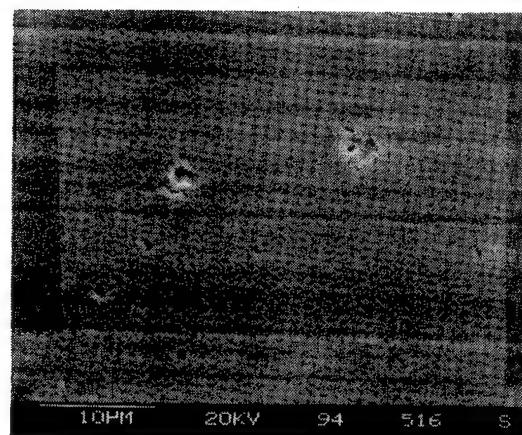
Figure 36 shows the typical appearance of the races after testing. As indicated by the surface finish traces, the small-scale roughness of the finish has been reduced somewhat by plastic blunting of the grind texture, but some discrete points of roughness were produced by micropitting and denting. As shown in Figure 37, the microspalling is sometimes associated with near-surface nonmetallic inclusion material-aluminum oxide particles of micron size (the presence of aluminum oxide was verified by EDAX). The ball surface, shown in Figure 38, appeared essentially the same as it did in the pretest condition. The wear process in this bearing appeared to be one of small scale fatigue damage to the steel races.

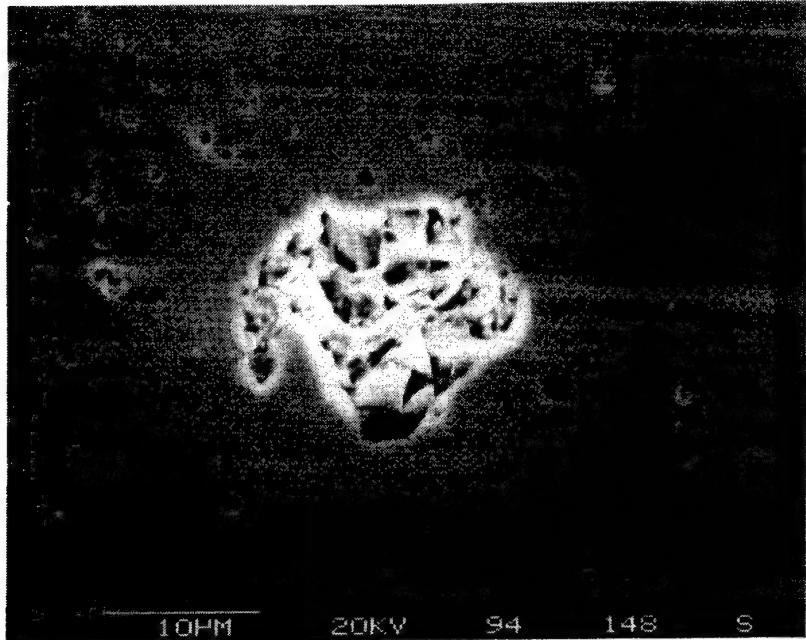
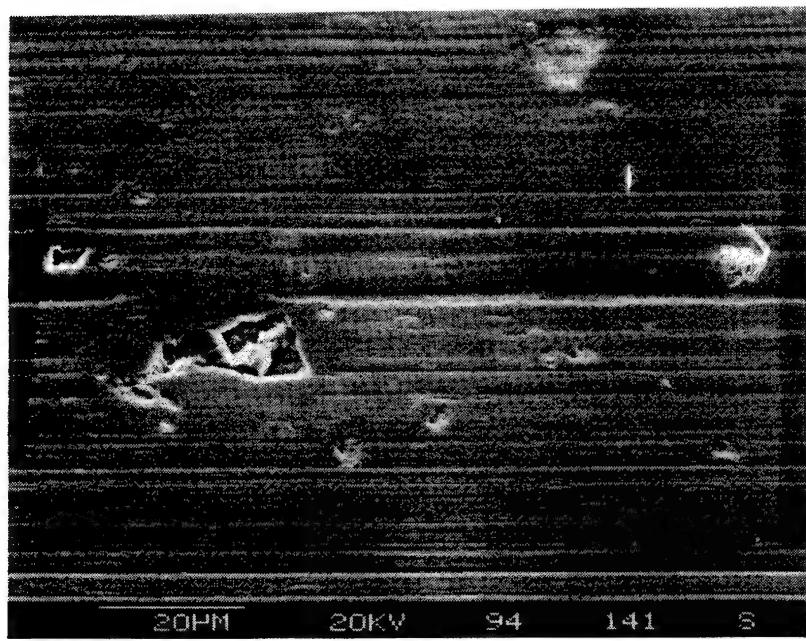
Figure 37 Micropitting Of AISI 52100 Races and Bearing A-1 At Near-Surface Al_2O_3 Non-Metallic Inclusion Particles: (a) Outer Race, (b) Inner Race.

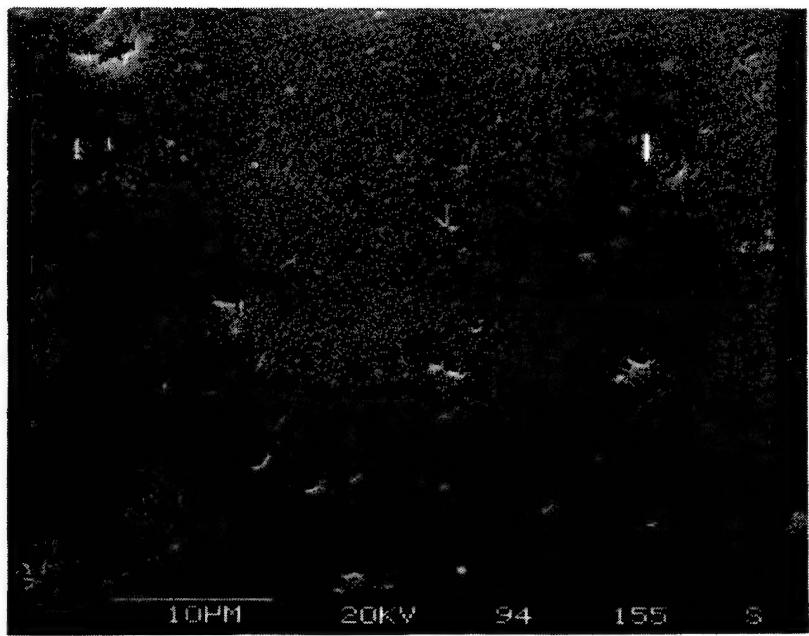
Figure 38 Post-Test Surface Condition Of NBD-200 Ball From AISI 52100 Races and Bearing A-2, Run 147 Hr. at 2.76 GPa (400 Ksi), $\lambda = 1.0$.

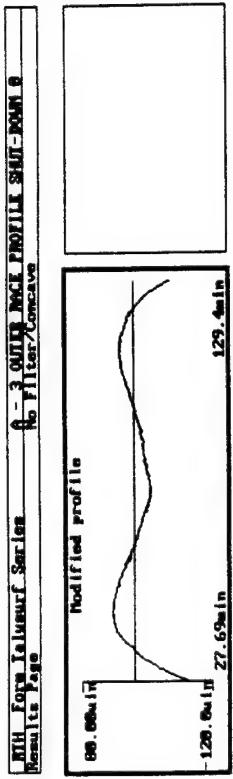
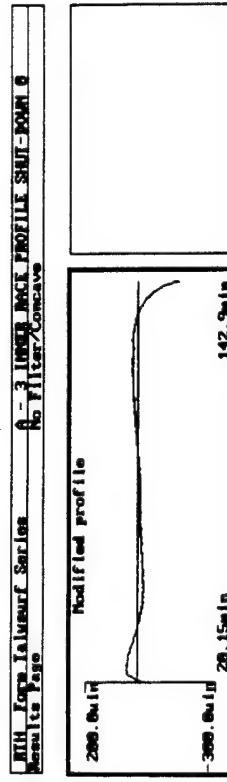
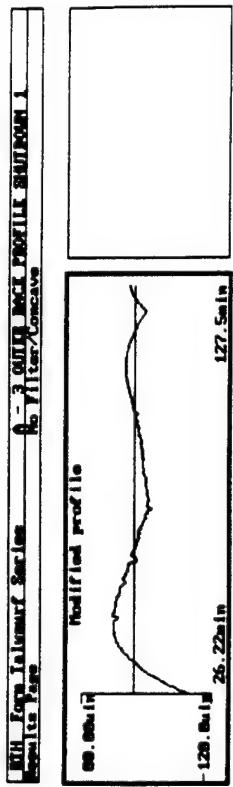
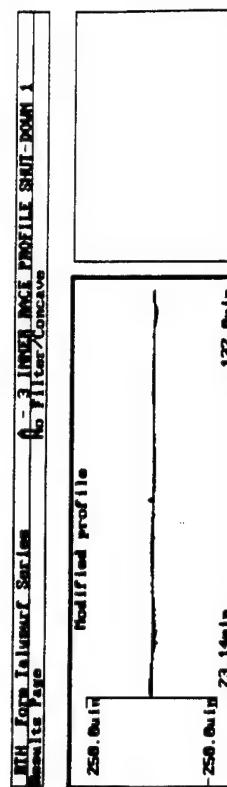
Bearing 52100-A-3 was run in an attempt to achieve a longer running time under the film thickness conditions of $\lambda = 1.0$. A run of 305 hours was completed on this bearing without fatigue failure of the races. Figure 39 presents the results of the pre-test and post-test measurements on the components of bearing A-3. The traces indicate a slight modification of the profiles of the races, primarily due to denting on the outer race, while the inner race became more nearly a perfect radius with running, due to small plastic deformations of the surface. No net removal of material was indicated, however. No wear tracks were visible on the balls, and the surface finish measurements were essentially identical before and after the test. The weight change measurements also showed no significant changes. Some features of the race appearance after test are shown in Figure 40. They consisted, as in the previous test, of some blunting of the grinding texture, along with denting and micro-spalling.

Ra Final = 1.3305 μ in
Rt Final = 12.6155 μ in

Outer Race
Ra Final = 0.9021 μ in
Rt Final = 23.9476 μ in

305 Hrs. 55.000 X 10⁶ Revs
2.76 GPa (400 ksi)
 λ = 1.0 T = 60°C (140°F)

Figure 39 Wear Test Results For AISI 52100 Steel Races and Bearing "A-3".

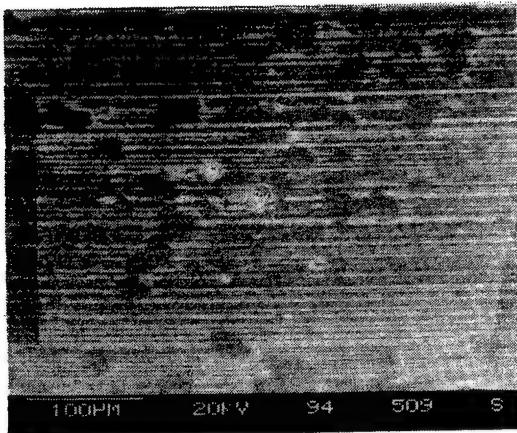
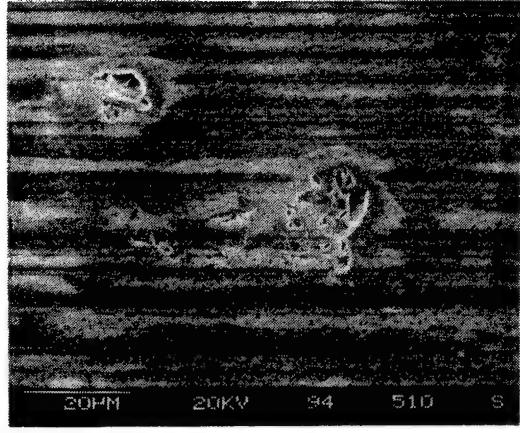
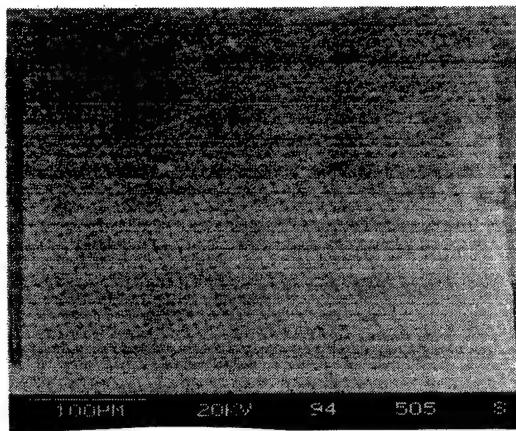
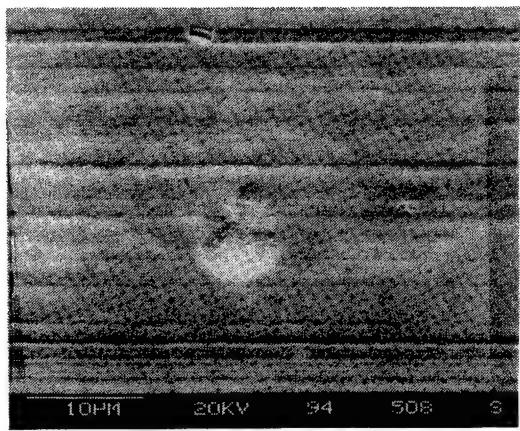
Figure 40 Post-Test Condition of AISI 52100 Steel Races and Bearing A-3, Run 305 Hrs., At 2.76 Gpa (400 ksi), $\lambda = 1.0$: (a) Outer Race General Appearance, (b) Outer Race Micropitting, (c) Inner Race General Appearance, (d) Inner Race Bruising.

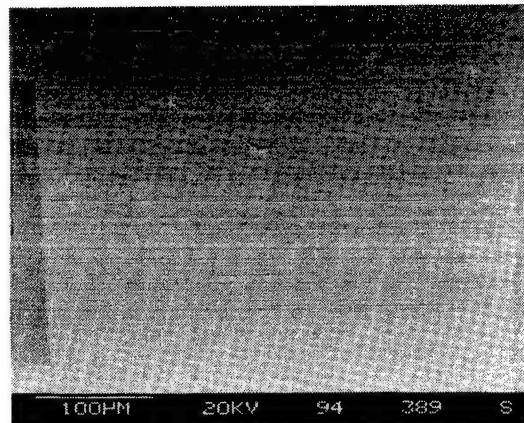
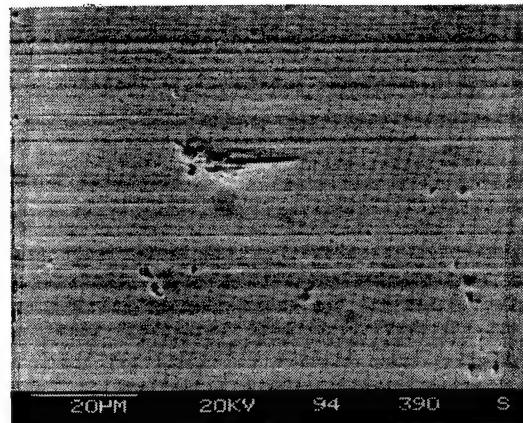
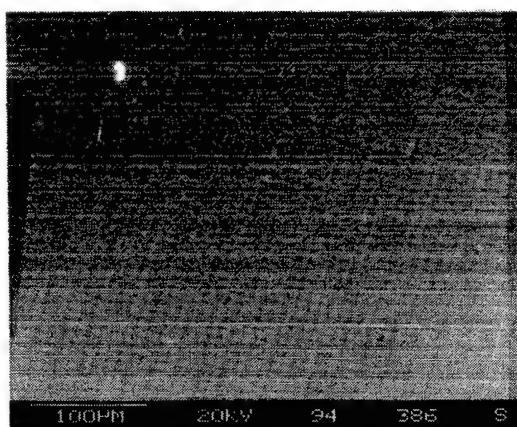
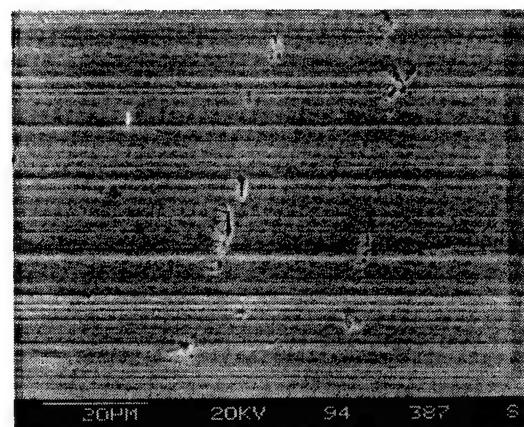
The pretest surface condition typical of the M-50 steel races is shown in Figure 41. The effect of the intersection of the large carbides with the race surfaces on the surface integrity is very apparent in these photos.

Figure 41 Typical Pre-Test Surface Condition Of M-50 Steel Races, Bearing B1: (a) Outer Race, General Appearance, (b) Outer Race, Pits Due To Removed Surface Carbides, (c) Inner Race, General Appearance, (d) Inner Race, Pits Due To Removed Surface Carbides. Races Were Sputter-Coated With Pd Prior To Photographing.

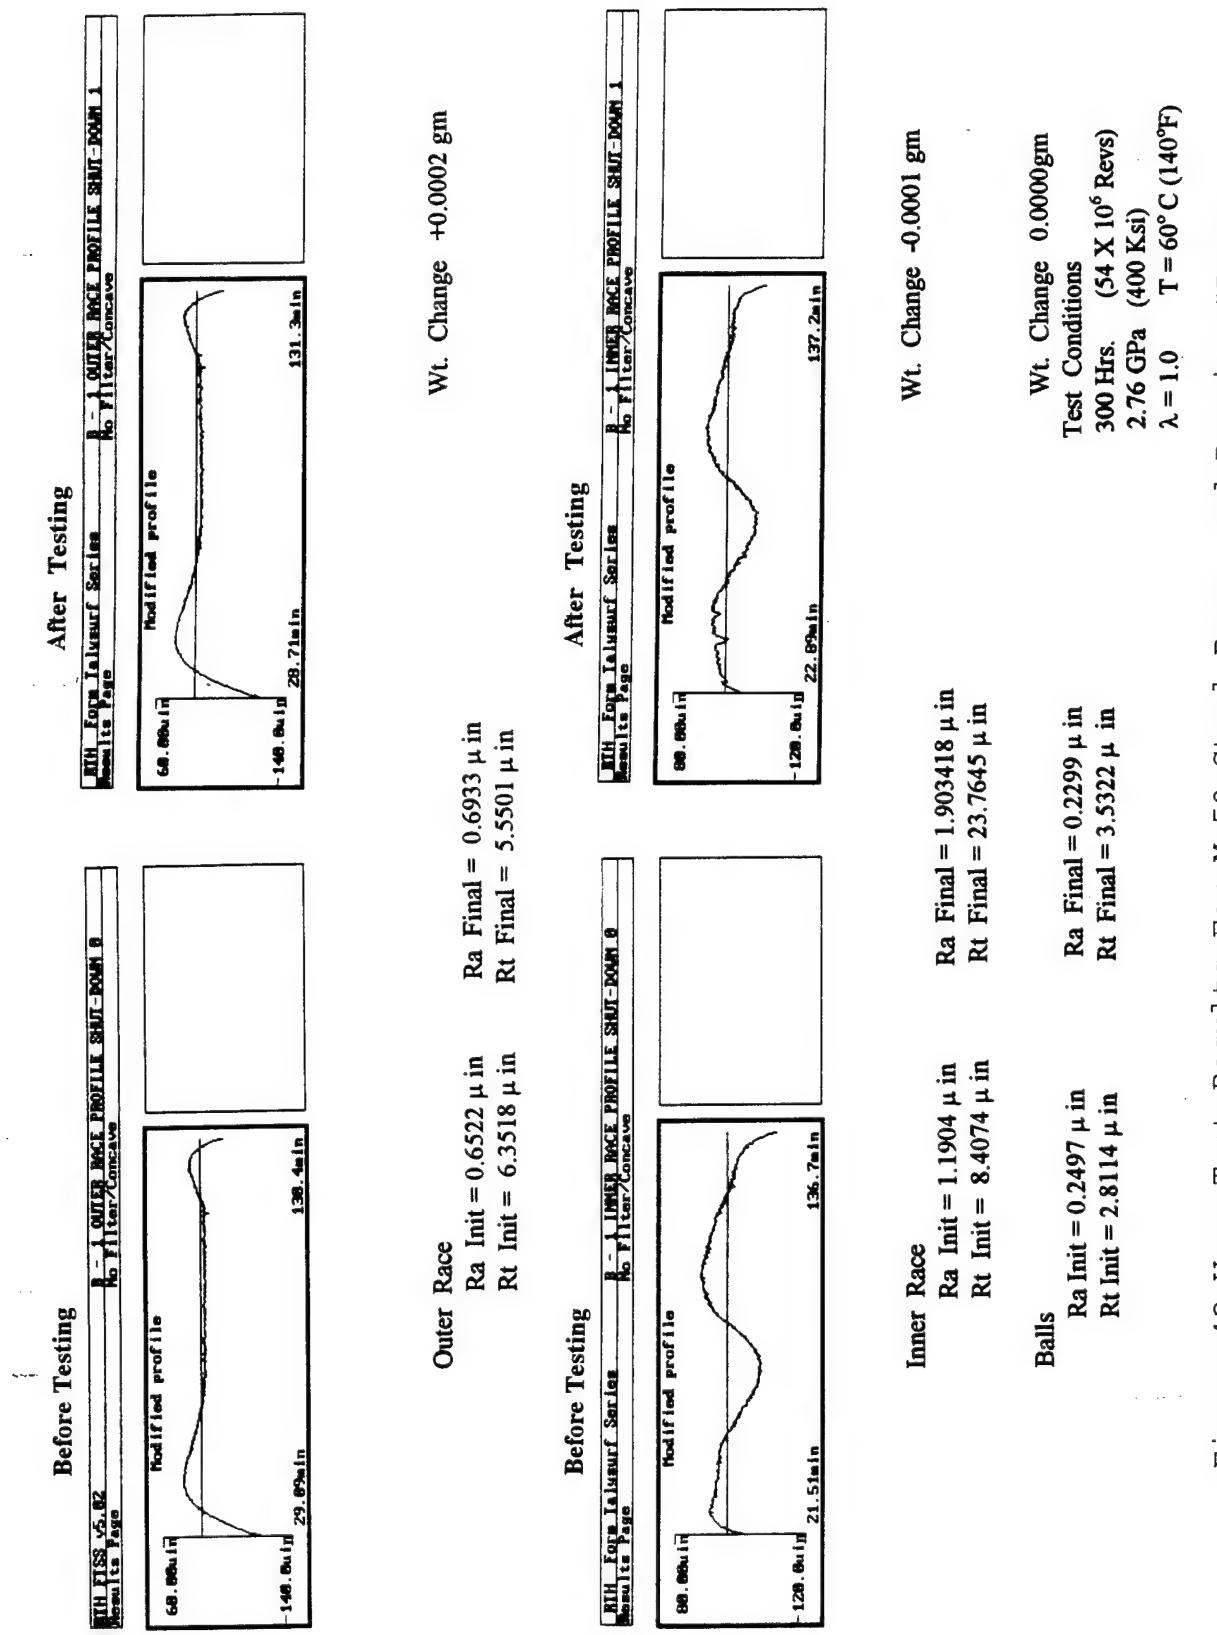
Bearing M50-B-1 was tested under conditions identical to those of bearing 52100-A-1, which failed by fatigue spalling just short of the intended 300 hour test time. The M-50 bearing completed 300 hours of running without fatigue failure on a macro-scale. Figure 42 summarizes the dimensional and weight data on the components of bearing B-1. The results were similar to those observed on the 52100 bearings.

Figure 42 Wear Test Results For M-50 Steel Races and Bearing "B-1".

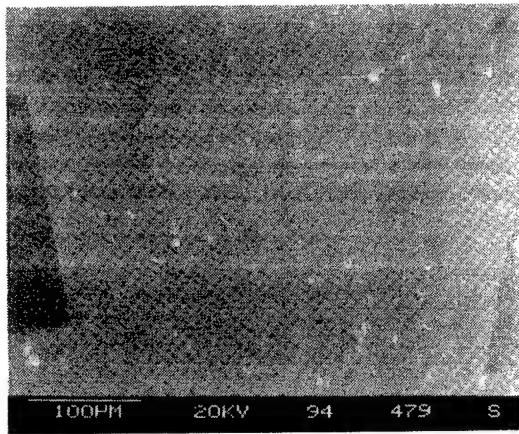
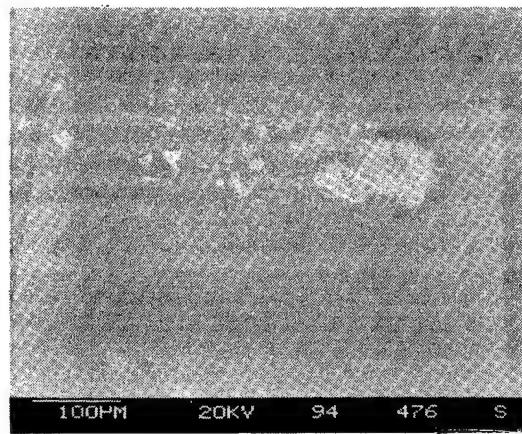
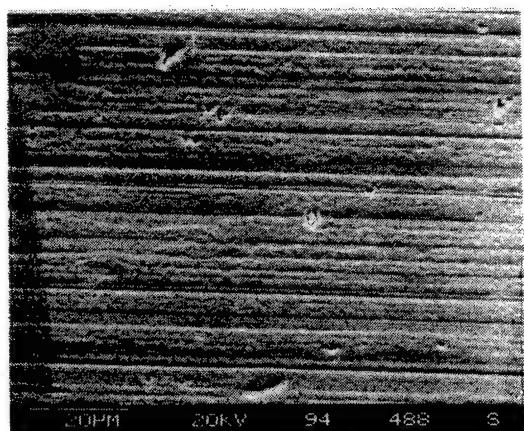
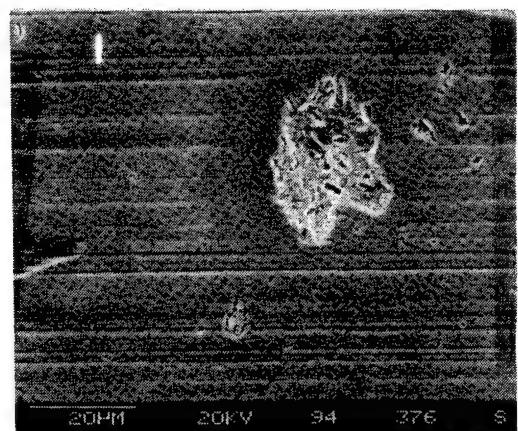
Essentially no measurable differences were detected between the profiles and surface finishes measured before and after running. Figure 43 shows, however, that fatigue microspalling had occurred on both the inner and outer races. These spalls appeared to have propagated from the large carbides described above. While the spalls were very small, less than 100 μm or less at the time of termination of the testing, they would have eventually led to the failure of the races. No wear track was detectable on the NBD-200 balls after the test.

Figure 43 Post-Test Condition Of Races and Bearing B-1 Run 300 Hrs. At 2.76 GPa (400 ksi), $\lambda = 1.0$: (a) Outer Race, General Appearance, (b) Micro-Spalling On Outer Race, (c) Inner Race, General Appearance, (d) Micro-Spalling On Inner Race.

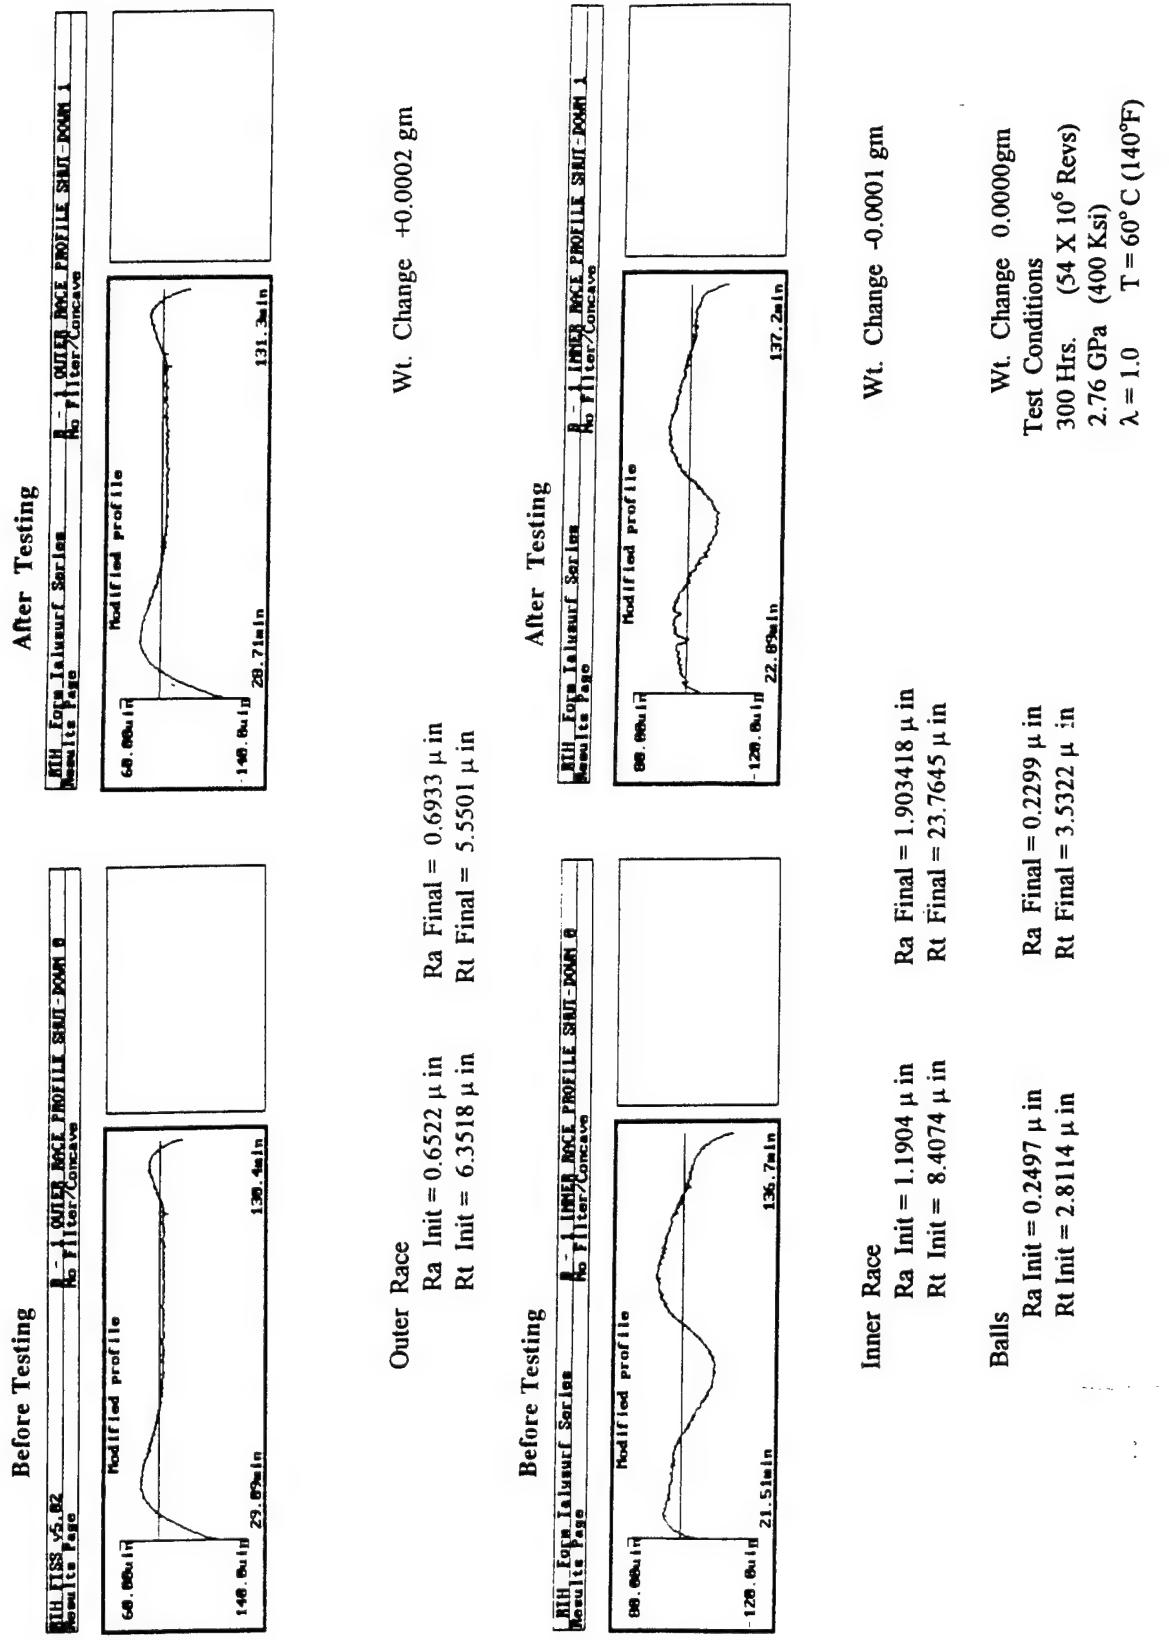
The test results for bearing M-50-B2 are shown in Figure 44. Even under these conditions of boundary lubrication, no measurable wear of the components occurred.

Figure 44 Wear Test Results For M-50 Steel Races and Bearing "B-2"

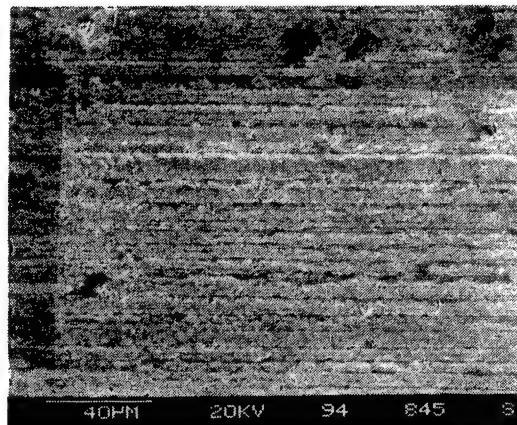
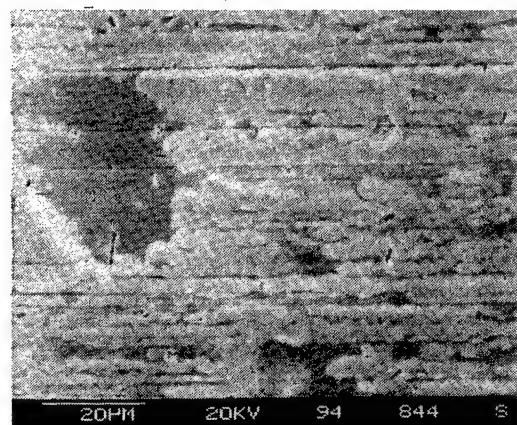
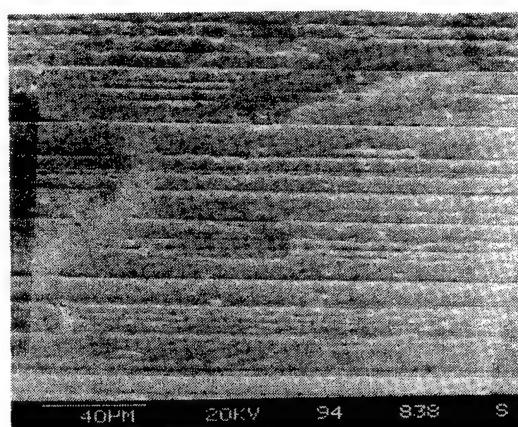
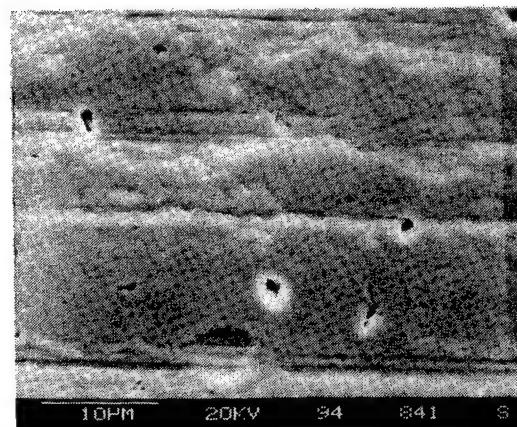
The SEM examinations of the tested races in Figure 45 show that the basic appearance of the finish was unchanged. An adherent coating, thought to be a product of degradation of the lubricant, was particularly evident on the surface of the outer race. No distinct wear tracks were visible on the balls from this test. The appearance of the ball surface in Figure 46 suggests that some of the original pits resulting from grain pull-out were filled in by surface film material.

Figure 45 Post-Test Condition of M-50 Steel Races and Bearing B-2, Run 150 Hrs. At 2.76 GPa (400 ksi), $\lambda = 0.3$: (a,b) Outer Race, (c,d) Inner Race. Races Not Pd-Coated Prior To Photographing Film Appears To Be Unremoved Friction Polymer From Lubricant Degradation.

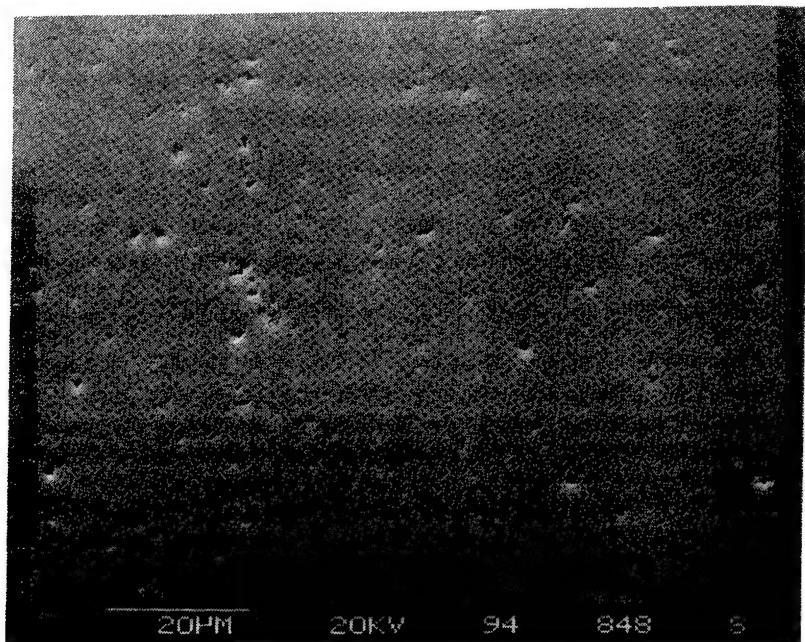
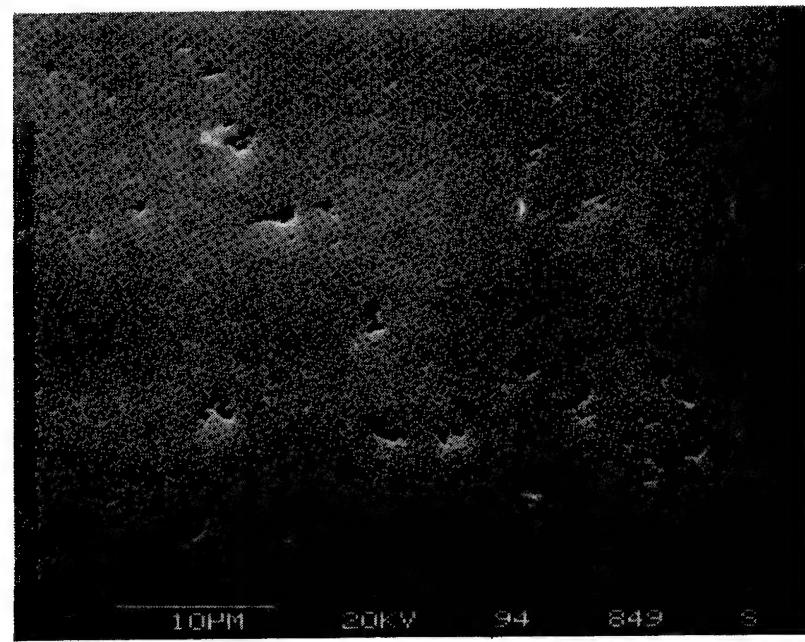
Figure 46 Post-Test Condition Of NBD-200 Ball From M-50 Steel Race and Bearing B2. Two Different Areas On Ball Surface Are Shown. Lubricant Film May Have Filled In Some Surface Grain Pullout.

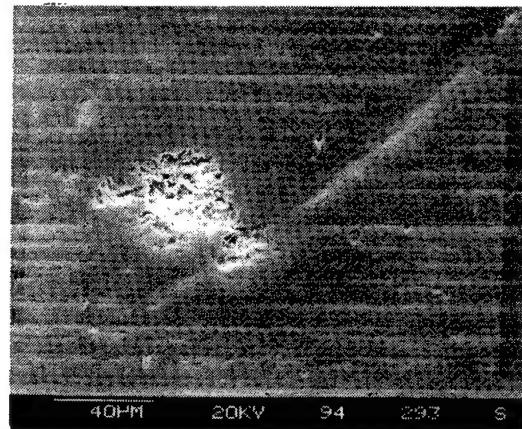
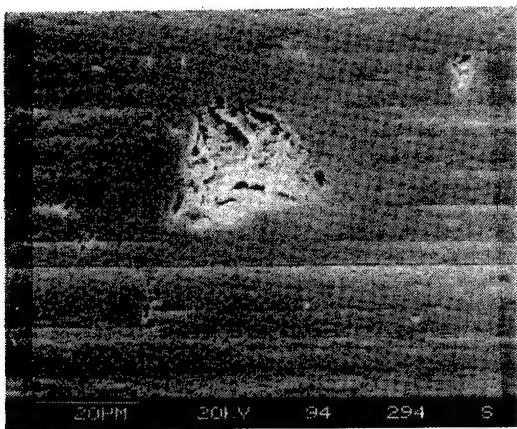
Figures 48 and 49 illustrate the post-test appearance of the outer and inner races, respectively. The outer race shows numerous microspalls, on the order of 10-15 μm in diameter. A large amount of debris damage from the microspalling, in the form of pitting, dents and apparent polishing-type wear was present. The inner race showed less damage from the circulated debris, but more fatigue micropitting than the outer race. The origins of the fatigue spalling were identified in several instances as alloy carbides (Mo, Cr, Fe) from remnant particles within the spalls. Figure 49d, however, shows a large carbide of this type on the surface within close proximity to a microspall which apparently originated at a cluster of alumina particles instead of at the carbide.

Figure 49 Post-Test Condition of M-50 Steel Inner Races and Bearing B3 Run 830 Hrs., at 2.61 GPa (379 ksi), $\lambda = 0.3$: (a) General Face Appearance, (b) Micropitting and Debris Gouge, (c) Micropitting And Debris Damage, (d) Micropitting And Debris Damage, Large Carbide At "A".

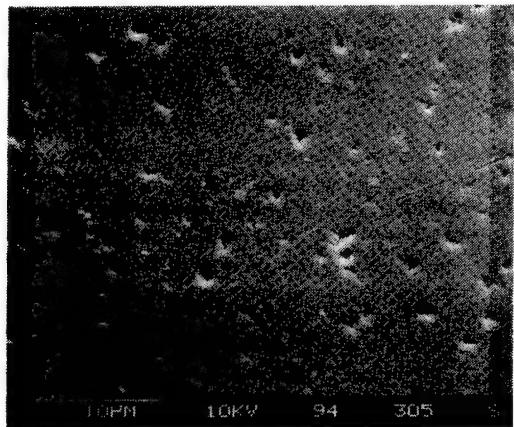
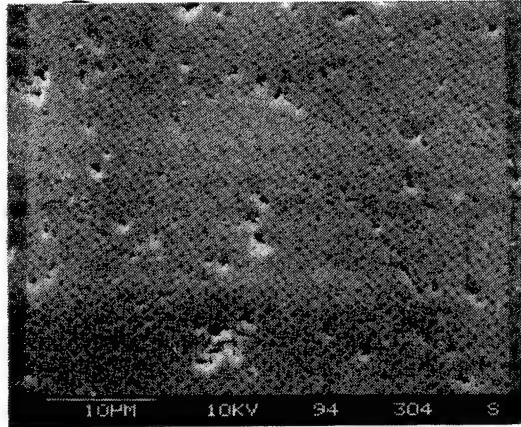
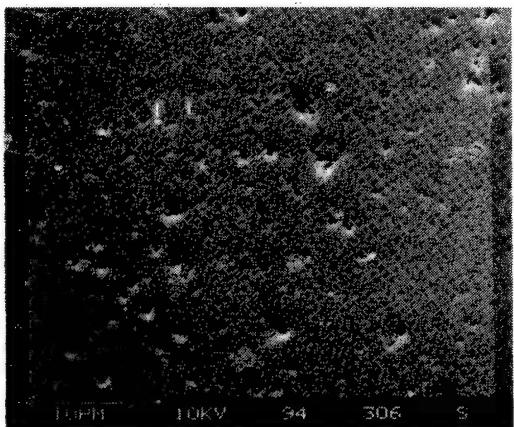
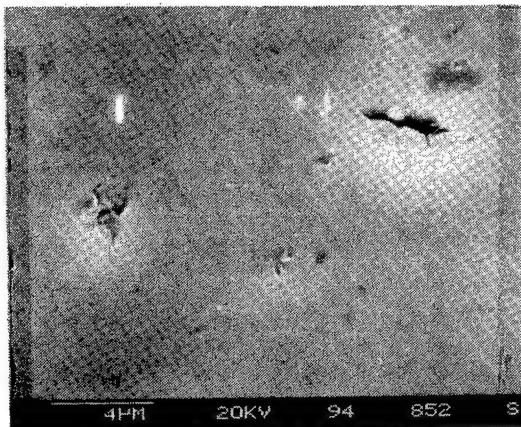
The ball surface appearances inside and outside the wear track are compared in Figure 50. The amount of grain pullout does not show much difference in the two areas. Photo (d) in Figure 50 shows evidence of lubricant degradation and wear products lodged in pores on the ball surface. Figures 51 and 52, from EDAX and wavelength dispersive x-ray analysis, indicate that the products in the wear track of the ball are enriched in phosphorus and zinc from the lubricant additives, iron from the races, carbon from the base oil and oxygen, combined with silicon nitride wear products.

Figure 50 Post-Test Condition Of NBD-200 Balls From M-50 Steel Races and Bearing B3, Run 830 Hrs., at 2.61 GPa (379 ksi), $\lambda = 0.3$: (a) Appearance Outside of Wear Track, (b) Appearance in Wear Track, (c) Appearance in Wear Track, Second Area, (d) Lubricant Degradation Product in Pits.

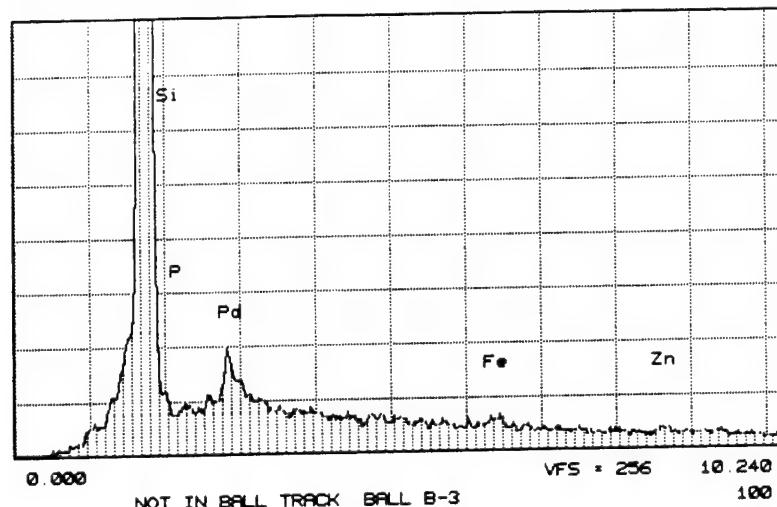
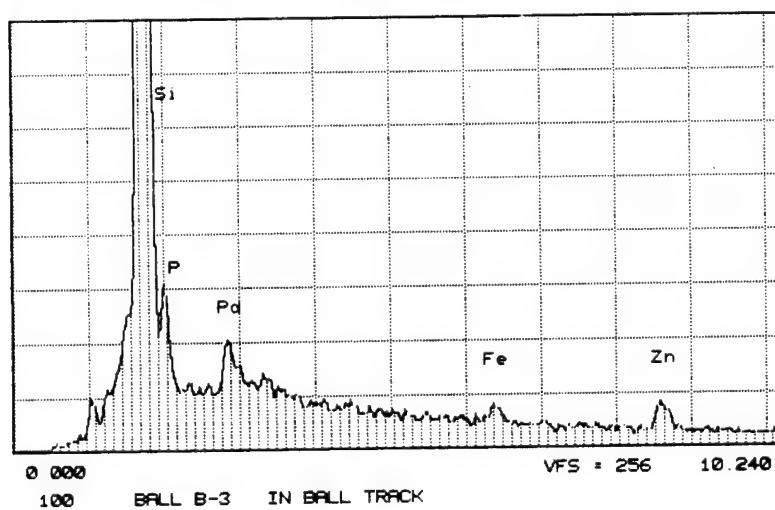
Figure 51 EDAX Analysis of a Post-Test NDB-200 Ball From M-50 Steel Races, Bearing B3. Top: Surface "Outside of" Wear Track, Bottom: Surface "In" Wear Track (Phosphorus, Iron And Zinc Are Indicated).

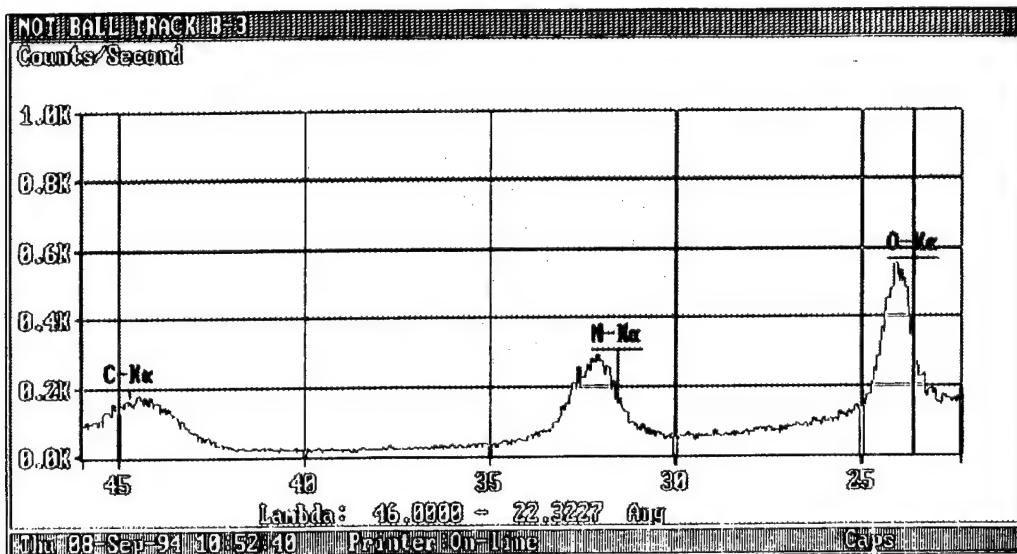
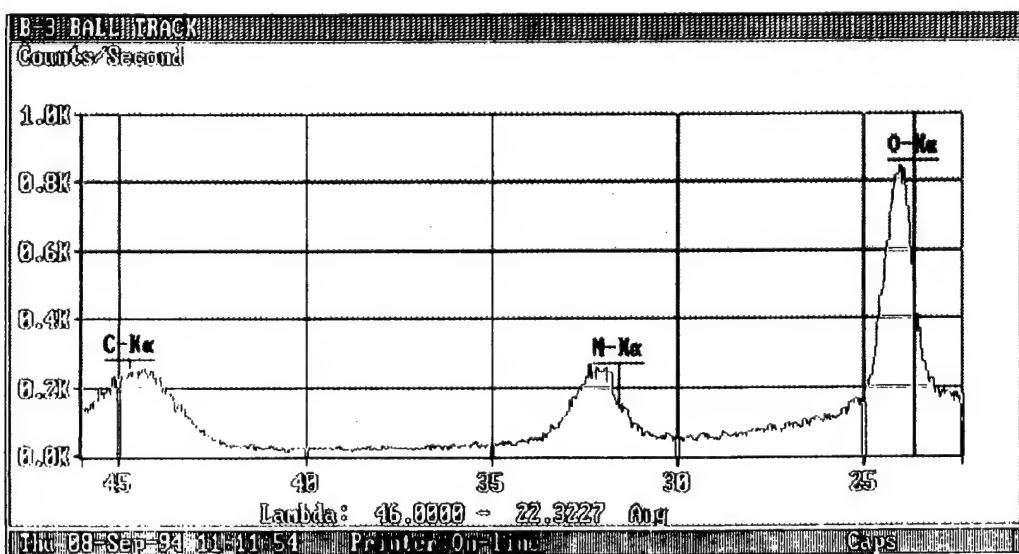
Figure 52 Wavelength Dispersive X-Ray Analysis Of Post-Test NDB-200 Ball From M-50 Steel Race and Bearing B3. Top: Surface "Outside of" Wear Track, Bottom: Surface "In" Wear Track (Pickup of Carbon And Oxygen Is Indicated).

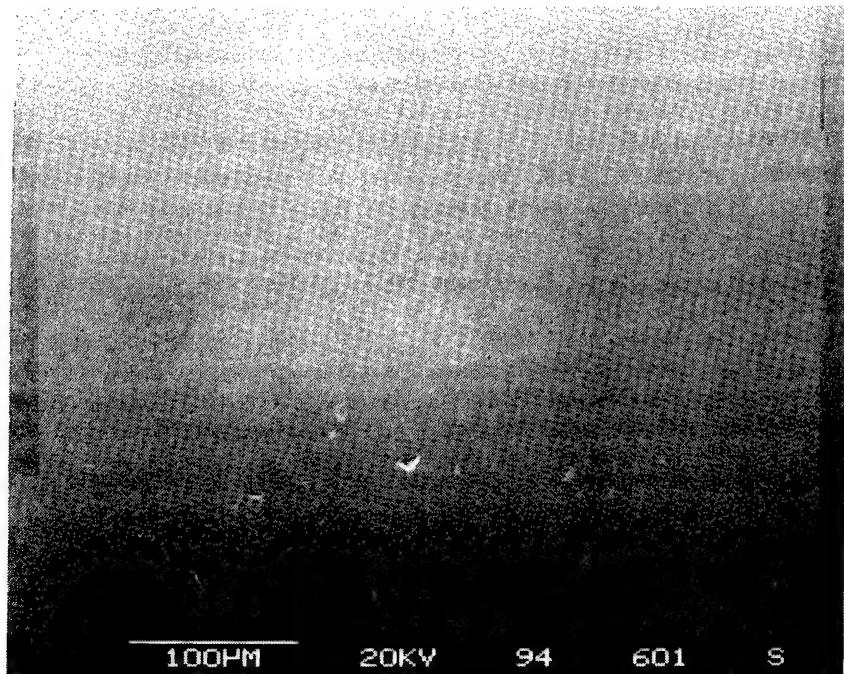
The pretest surface texture of the M-50 balls is shown in Figure 53 to be greatly different from that of the NBD-200 balls (compare to Figure 29). The steel surface was free of the small pores resulting from grain pull-out that characterized the NBD-200 balls. The surface of the M-50 balls was plastically deformed, as well as abraded by the finishing process. Some deeper gouges may have been partially covered over by the plastic flow of the surface. Such areas, even though covered, could still act as spall initiation sites under rolling-contact conditions.

Figure 53 Pretest Surface Condition Of M-50 Steel Balls Tested In M-50 Steel Races and Bearing X1.

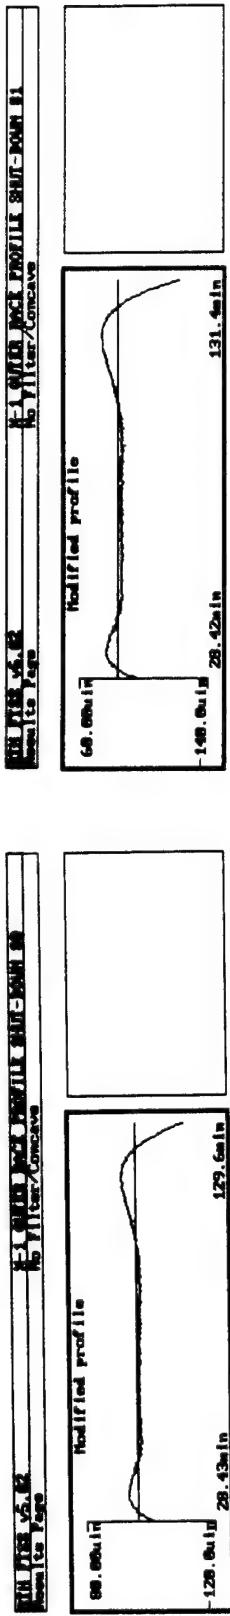
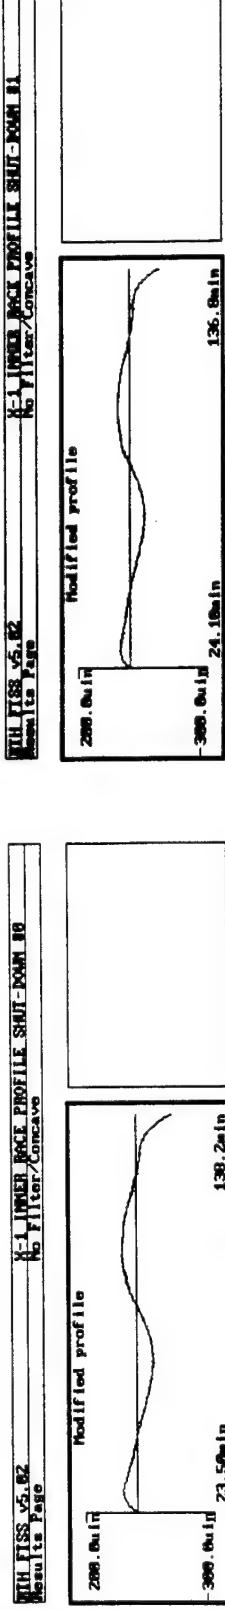
Figure 54 Wear Test Results For All M-50 Steel Races and Bearing X1.

The wear test data for the M-50 steel bearing are shown in Figure 54. The profile traces of the races showed no detectable changes due to running. The surface roughness of the balls and outer race increased slightly from their original values, but the race finishes, after testing in the all-steel bearing, were measurably smoother than those that were shown in Figure 47 for the hybrid bearing M-50-B3. Weight losses of the inner race and the balls were apparently greater than those of the hybrid bearing, even though this bearing was run for only 500 hours, as compared to 830 hours for the hybrid bearing, and at a lower contact stress.

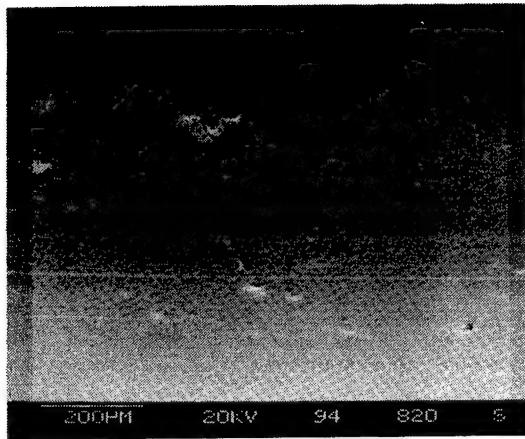
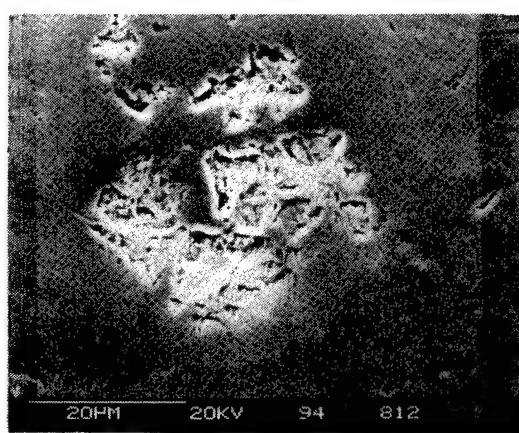
Figure 57 Post-Test Appearance Of M-50 Balls From Bearing
M-50-X1 Run 500 Hrs. At 2.27 GPa (329 ksi) $\lambda = 0.3$:
(a) Outside Wear Track Showing Minor Debris Denting,
(b) In Wear Track Showing Microspalls, (c) In Wear
Track, Smoothing Of Surface Finish, (d)
Microspalling.
